CLARENCE CANNON DAM & MARK TWAIN LAKE

FOUNDATION AND EMBANKMENT COMPLETION REPORT

PART II MAIN DAM

VOLUME I — NARRATIVE SECTIONS 1 THRU 9

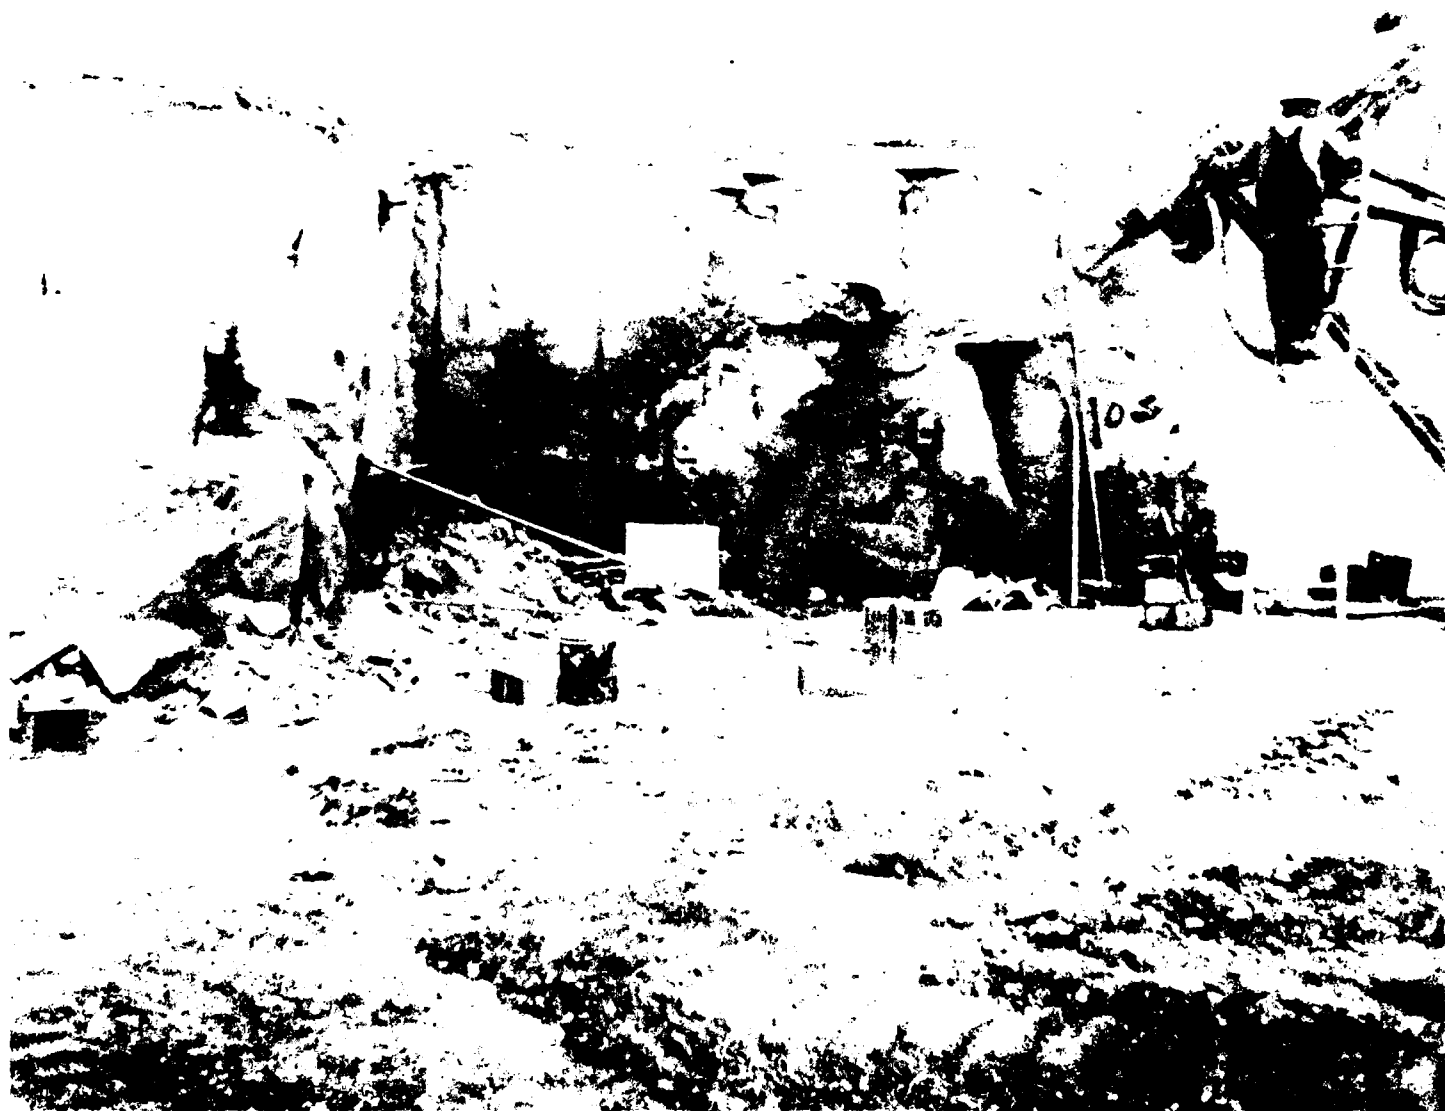
Typical rock bolt drilling operation on downstream foundation wall for Monolith D-15 with a 3700 Gardner Denver Air Track.
